**Name Of Dam:** STONY CREEK NO. 9

**Location:** SHENANDOAH COUNTY, STATE OF VIRGINIA

**Inventory Number:** VA 17101

## PHASE I INSPECTION REPORT

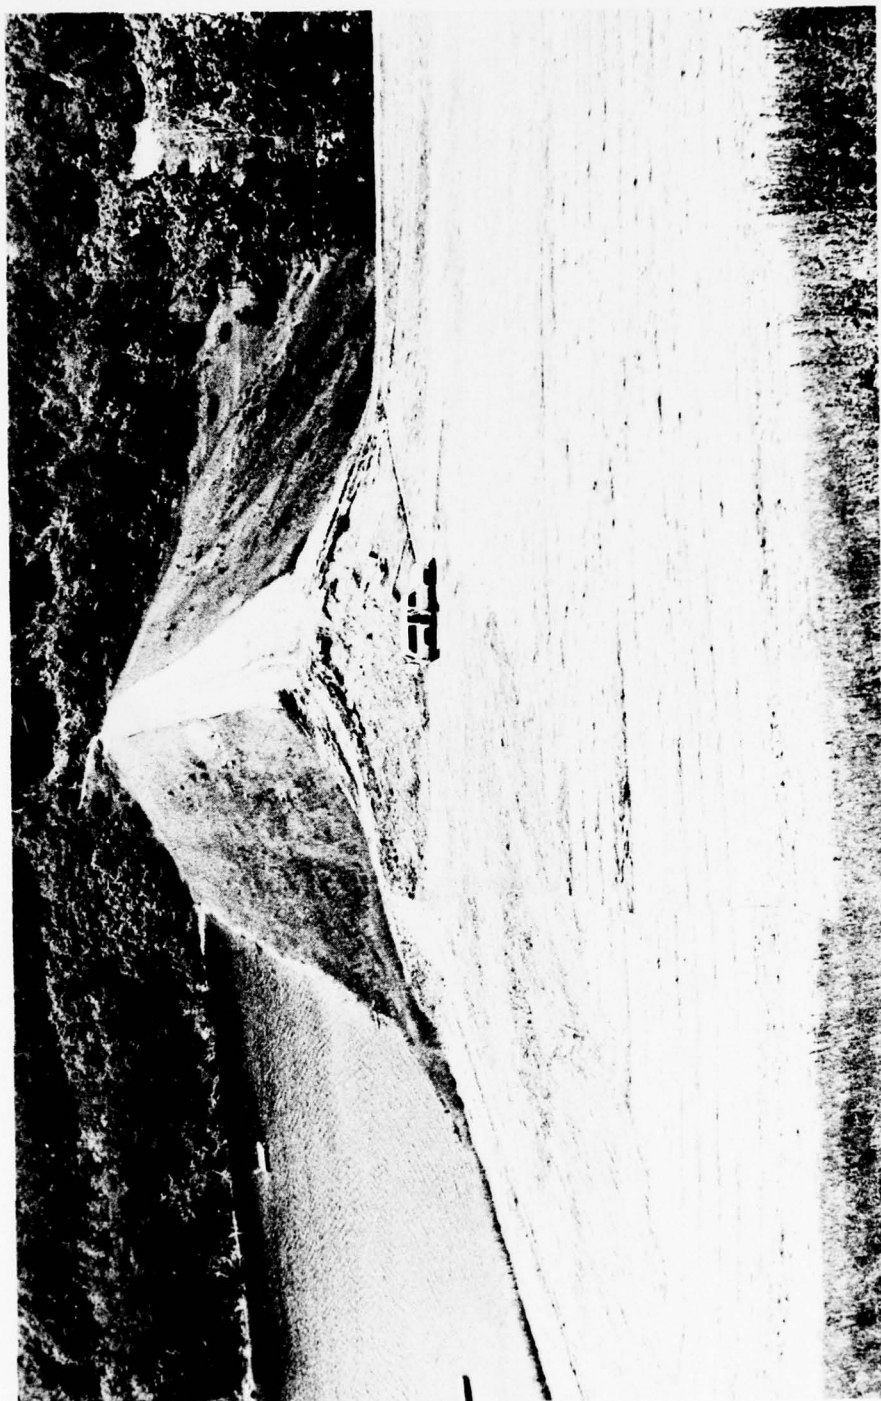
OVERALL VIEW OF DAM

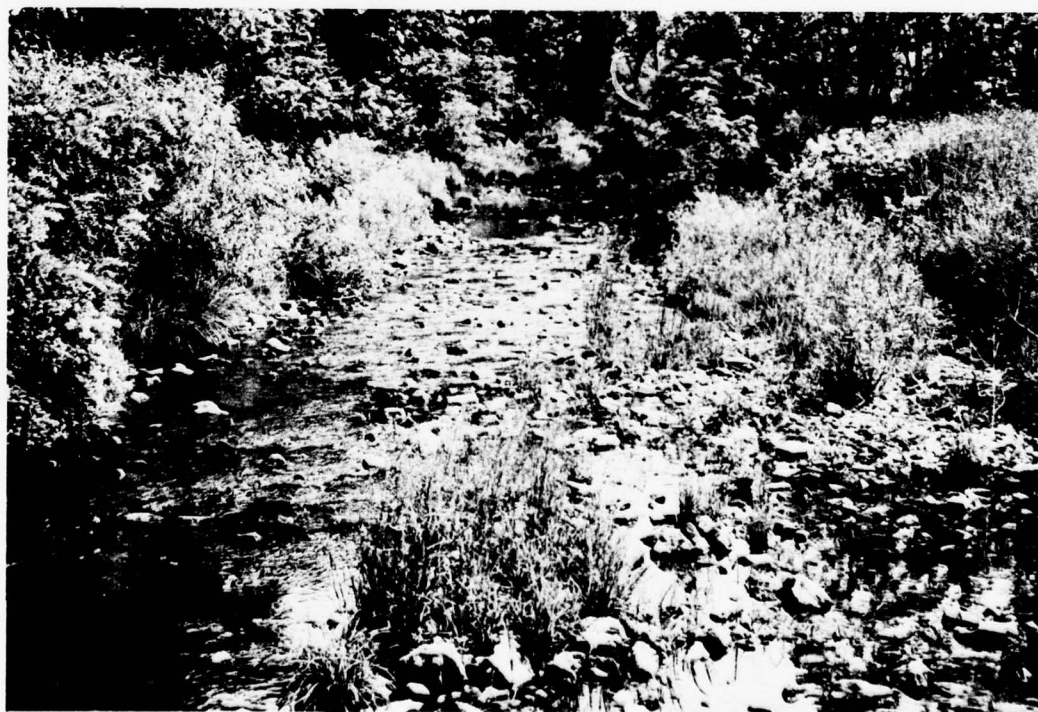
PHOTO 3

Non-measurable clear seepage was present at elevation 1317 for 50 feet to the right and 80 feet to the left (Photo 5) of the outlet pipe (see Photo 3). The grounds to the left of the pipe were wet for 15 to 20 feet out from the toe of the abutment. There was also another clear, non-measurable seep about 10 feet in diameter at the left end of the bench on the downstream face which may be spring seepage from the hillside.

- 6.2.1 Visual Observations: No evidence of instability in the embankment or cut slopes was observed. There are some structural cracks in the riser (see Photos 1 and 2). Clear seepage was noticed in the vicinity of the outlet of the principal spillway on both sides (see Photos 3 and 5). Minor, clear seepage occurs in the bench on the downstream slope at the left abutment.
